**Central Wellness Center Feasibility Study
Phase I Adaptive Reuse Scope of Work
For Discussion at Special Board Meeting on July 23, 2019**

Prince George Central Wellness Center

Phase 1 Adaptive Reuse Scope of Work

July 17, 2019

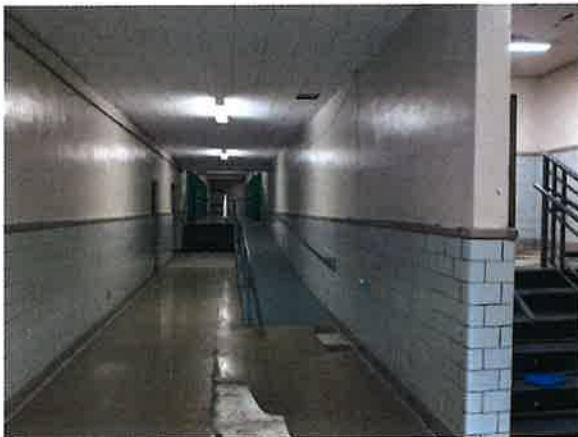
Ramps have been installed in two hallways to provide access to the boy's locker room, maintenance shop, and food bank. The ramps were not part of the original design and were added at an unknown date. The ramp slopes exceed accessibility requirements and the ramps do not have landings as prescribed by the code. The ramp guard rails are only 36" tall and do not meet code requirements.

As required by the international existing building code, the ramps will need to be replaced or modified to provide code compliant slope and landings. New code compliant guard rails and handrails will need to be installed along the ramps.

The existing ramps will be completely demolished, and new ramps will be constructed. The new ramps will have painted CMU walls below concrete slabs. The ramp on the exterior leading to the rear parking lot will have a brick veneer where the wall is visible below the ramp. An intermediate landing will be required because the rise of the ramp exceeds 30". New handrails and guard rails consisting of steel pipe rail will be required along the ramp. The enclosed diagrams show the locations and arrangement of the ramps. In the first phase, the ramp connecting to the rear parking lot will not be covered.

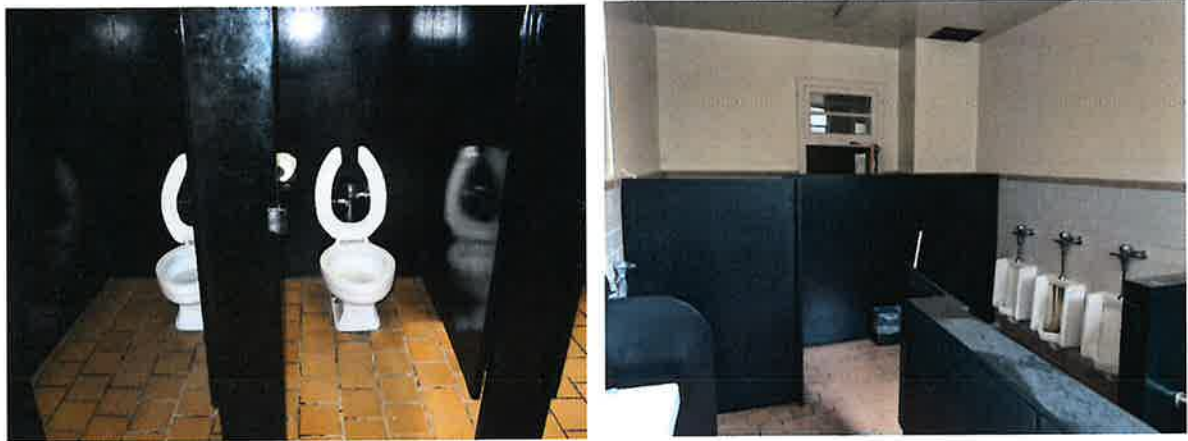
Restroom fixtures in the first-floor gang restrooms have been cleaned and maintained. These fixtures were observed to be operable; however, they do not appear to meet accessibility requirements for height and spacing. Partial height toilet partitions in the gang restrooms are primarily painted stone; however, some partitions have been constructed with plywood and painted black to match the stone. The partitions only provide partial privacy and do not allow for adequate clearance in required ADA stall locations. Fixture spacing is generally tighter than modern standards.

Gang restrooms on the first floor will be renovated to provide the majority of toilet fixtures that will be required for the business and assembly occupants. The existing gang restrooms on the first floor are spacious and will accommodate the required fixtures. The existing restrooms will be gutted, and new fixtures, plumbing, walls, toilet partitions, floor tile, wall tile, and drywall ceilings will be provided. Wall tile will extend to the ceiling. New fixtures will be needed for ADA compliant stalls. New lighting, plumbing and mechanical systems will be provided as described in the following sections.
